HEDGE MANAGEMENT PLAN FOR SAINT-GAUDENS NATIONAL HISTORIC SITE

CORNISH, NEW HAMPSHIRE

Olmsted Center for Landscape Preservation
National Park Service, Boston, Massachusetts, 2008

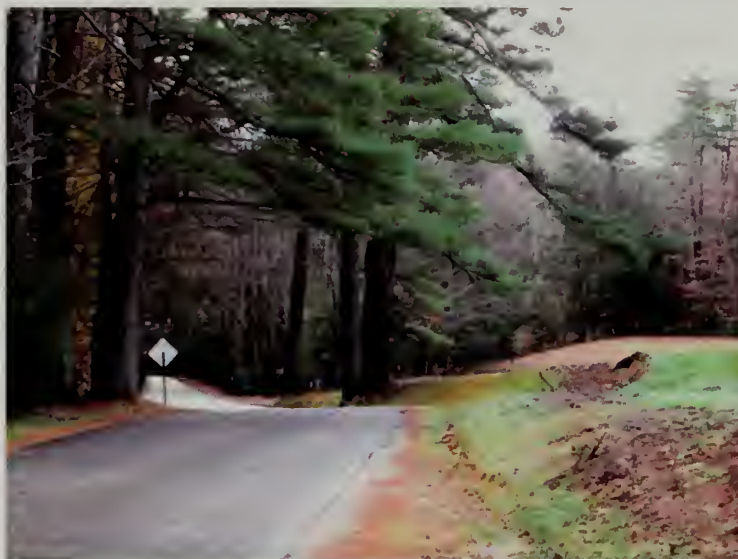
Figure 3.2: View looking west along Saint Gaudens Road showing site of west meadow hedge, 2006. The uphill alignment most likely dates to the c.1970 replanting. The mature white pines in the background are probably remnants of the original (c.1893-94) hedge (SUNY ESF).

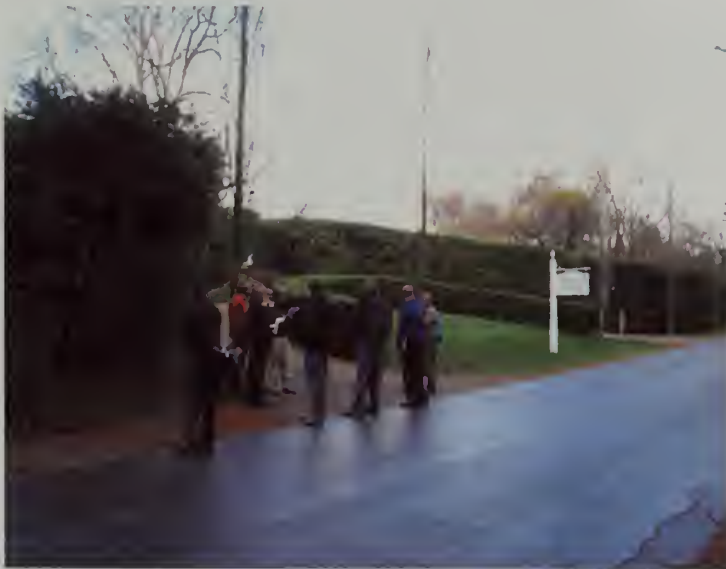
single row with 18-inch spacing. It is in good condition with a full, compact canopy (see Figures. 3.5, 3.6).

Figure 3.5: Horseshoe hedge, general view looking east along Saint Gaudens Road showing inner and outer sections, 2007 (SUNY ESF).

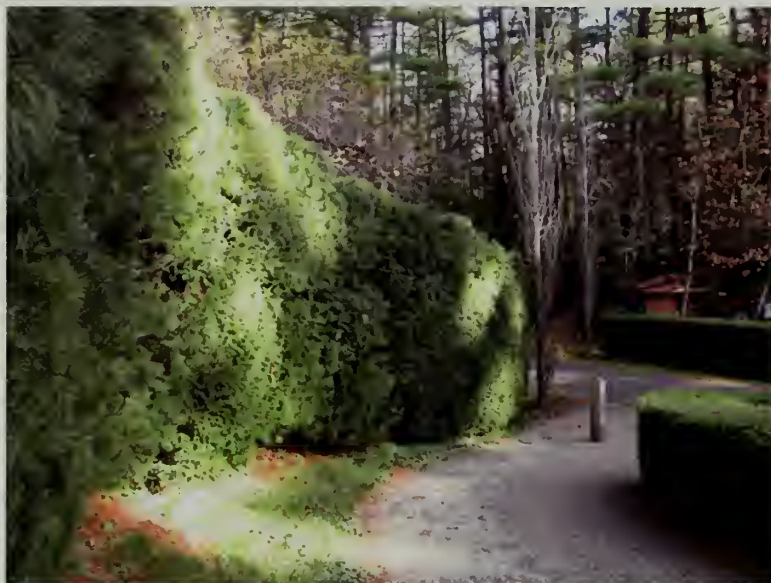
Figure 3.6: Horseshoe hedge, detail of east side of outer section (H-3) showing tapestry of white pine and hemlock, 2007 (SUNY ESF).

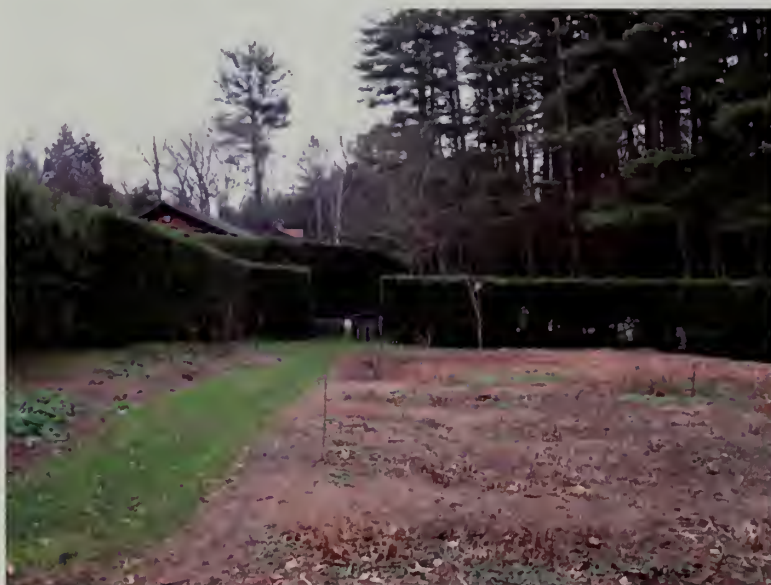
Figure 3.8: The cutting garden hedge, view looking east showing the opening at the service drive and the change from hemlock to white pine in section H-6 (left), 2006 (Olmsted Center for Landscape Preservation).

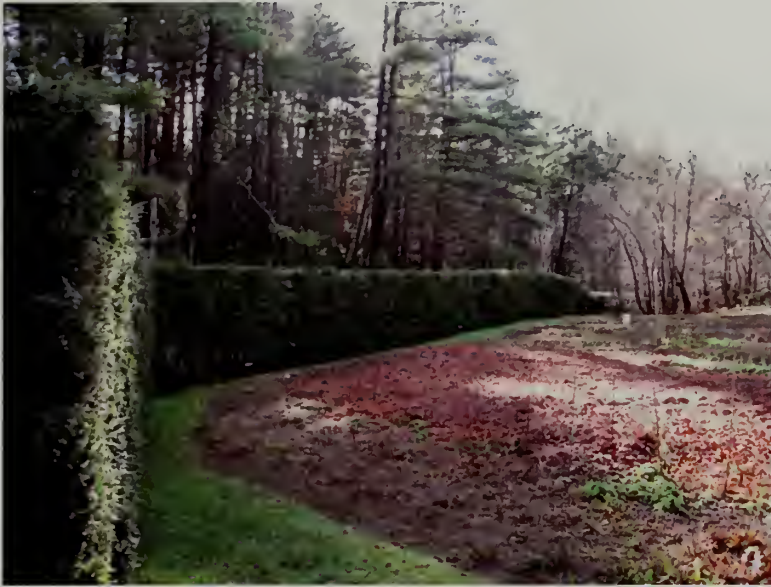
Figure 3.9: The cutting garden hedge, view looking west showing generally full side canopy on garden side of section H-5, with Japanese tree lilac grove in the background, 2006 (SUNY ESF).

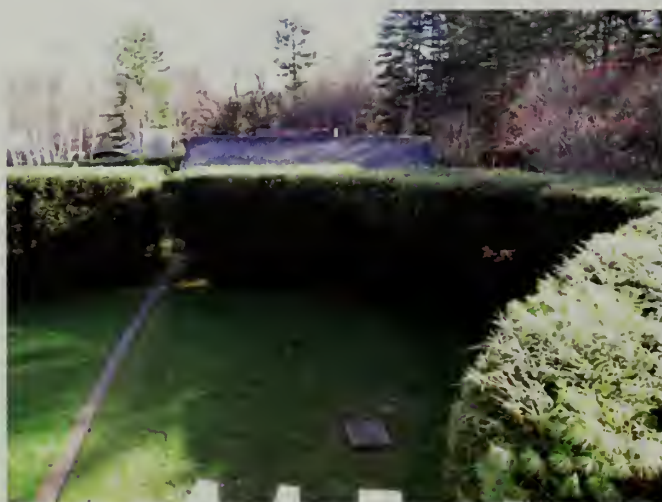
Figure 3.13: The kitchen hedge, view looking east from the second floor of Aspet showing general conditions, 2007 (SUNY ESF).

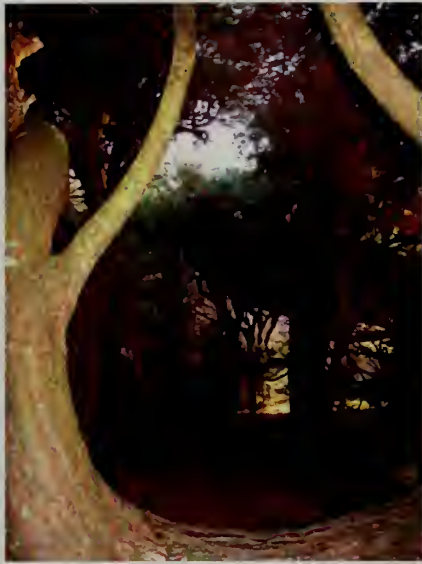
Figure 3.14: The kitchen hedge, view looking through the interior showing massive branching of aged hemlocks, 2006 (SUNY ESF).

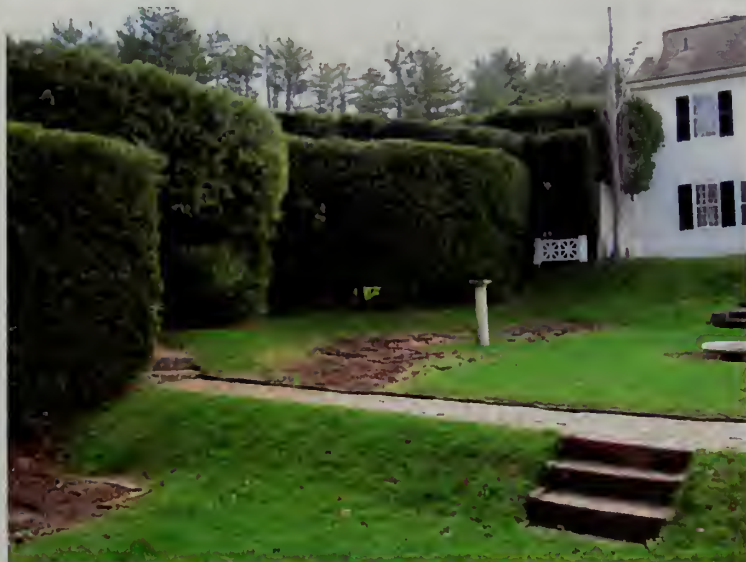
Figure 3.16: The kitchen hedge, view looking southeast at section H-8 extending above the terrace garden hedge (H-13) and stepping up adjacent to Aspet on the upper terrace, 2006 (SUNY ESF).

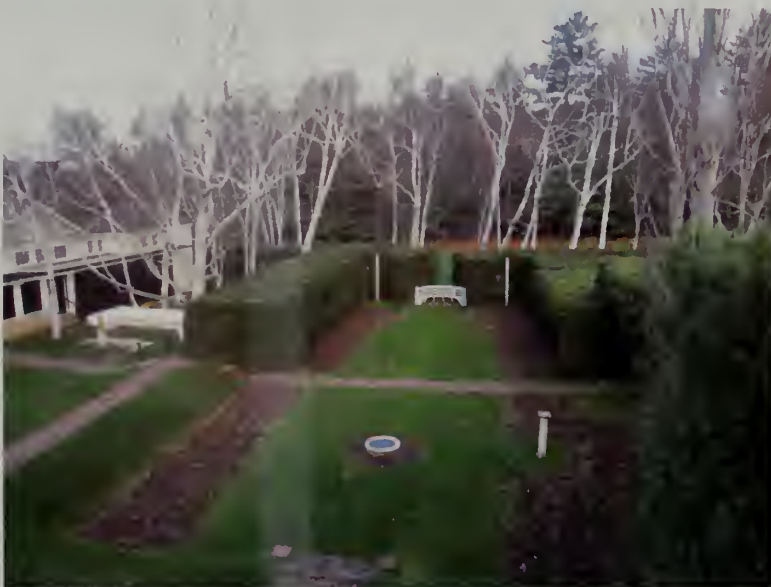
Section H-14 is a shared hedge with the terrace garden to the west. It is mixed white pine and hemlock, originally planted in c.1903 and later interplanted (see Figure 3.27). This section has a single row, and is 8 to 10 feet tall and 12 feet wide, with recent white pine interplanting on the Adams side that is not thriving apparently due to shade. It is full on the top but weak on the Adams and terrace garden sides.

Figure 3.27: Overview of the terrace garden hedge on the lower terrace looking north from the second floor of Aspet, 2006. Note the Pan grove hedge to the left and Adams hedge to the right (SUNY ESF).

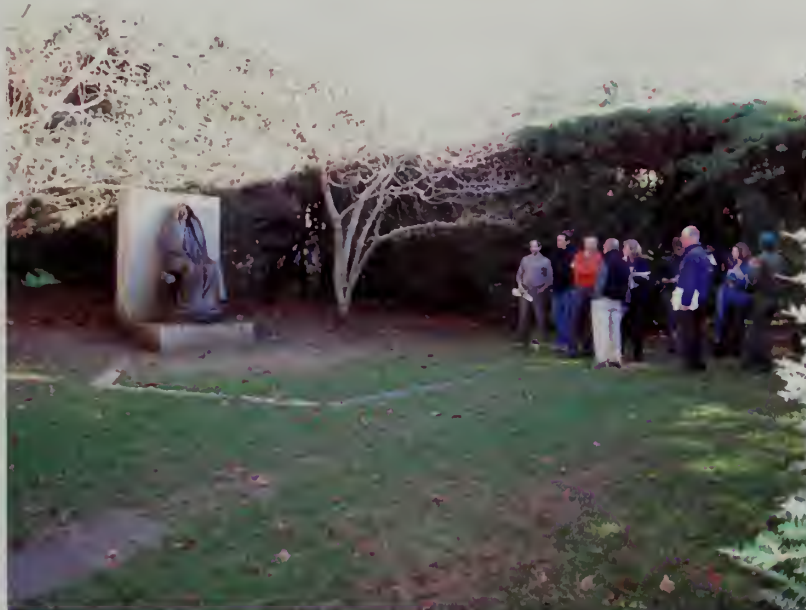
Section H-16, framing the south side of the Adams Memorial, is mixed white pine and hemlock planted in c.1893–94 with later interplanting. To the south, it frames the north wall of the Adams vestibule. This section has a single row with later infill along the hedge, and is 10 feet tall, 6 feet wide, with a non-historic arched opening from the Adams vestibule. It rises above adjoining section H-14, is level with the adjoining H-13 (terrace garden hedge), and is lower than H-17 (Adams-Shaw divide). Section H-16 has a mostly full canopy with weak areas around the arched opening and in the shade of the magnolia (Figure 3.32).

Section H-17, forming the east wall of the Adams Memorial and the divide with the adjoining Shaw Memorial, is mixed white pine and hemlock planted in c.1893–94 with later interplanting. It is a double row with infill along the edges (see Figures 3.31, 3.32). This section rises above all other adjoining hedge sections at 18 feet tall. It consists of several very large, aged hemlock trees, with an overall width of 10–12 feet. The hedge is weak on the Adams side, with approximately three-quarters of its side canopy lost due primarily to heavy shade from the adjoining magnolia trees flanking the Adams Memorial.

Figure 3.32: The Adams hedge, view looking southeast at sections H-16 and 17, 2006 (SUNY ESF).

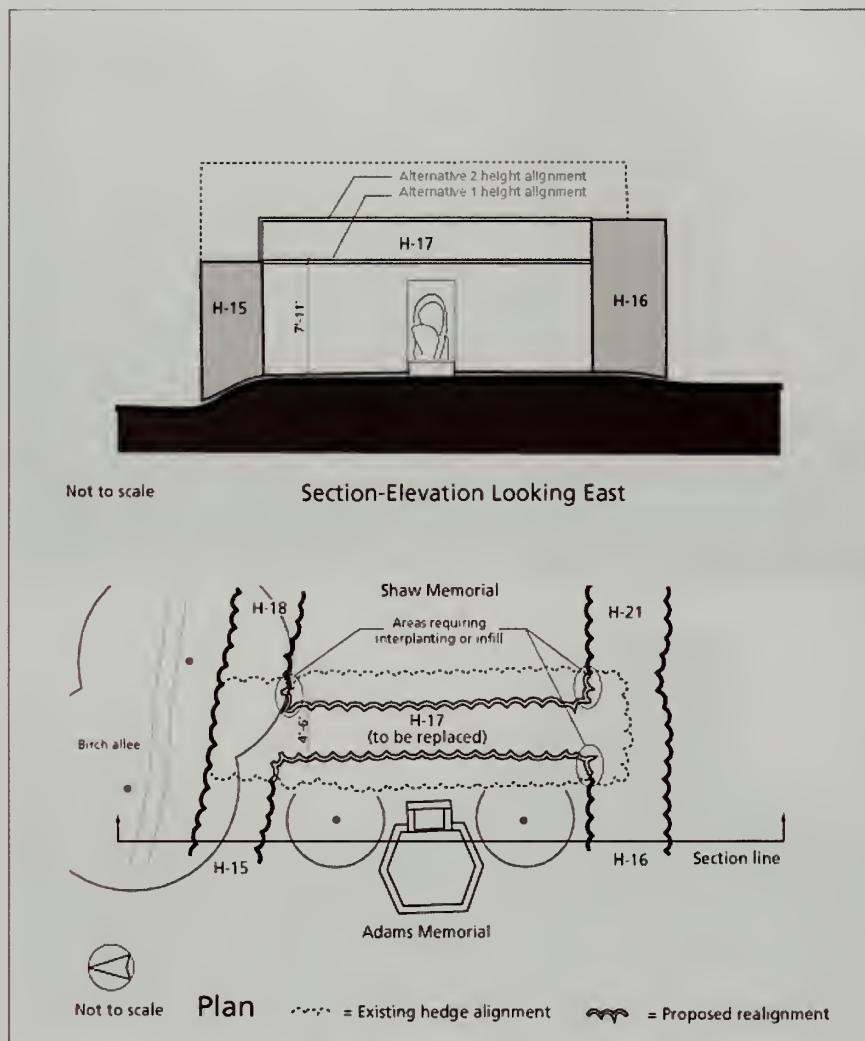
Figure 3.33: Plan and section-elevation detail of H-17 and adjoining sections in the Adams and Shaw hedges showing proportional relationships (SUNY ESF).

The existing location and alignment of this hedge is generally correct. The northern extension of H-17 over H-15 and H-18 (facing the birch allee) and over H-16 and 21 to the south appears to be a non-historic condition, and therefore this extension should be removed and the hedge kept to the interior sides of the adjoining hedges (Figure 3.33).

Section H-16 should align in height with section H-21 in the Shaw hedge and H-13 on the middle terrace of the terrace garden hedge, as it does now. Sections H-14 and H-15 should align in height with adjoining sections H-12 and H-15 bordering the birch allee. There are two alternatives for the alignment of section H-17 (see Figure 3.33):

extensions should be removed and the hedge kept to the interior face of the adjoining hedges (see Figure 3.33).

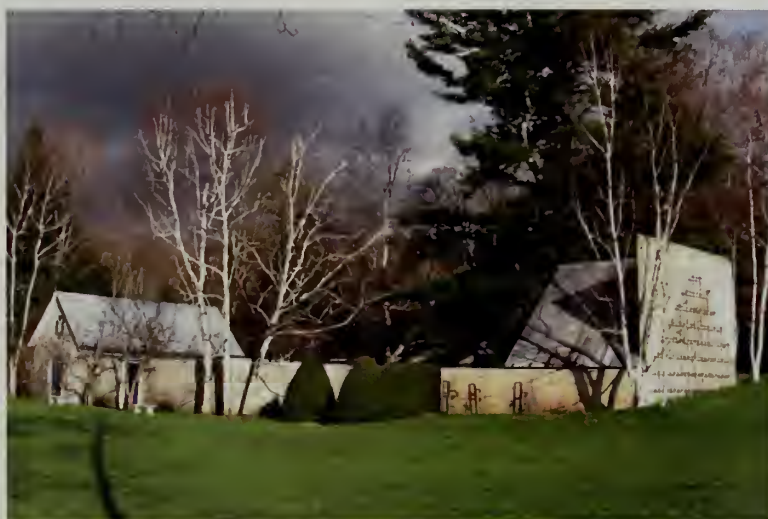
Figure 3.40: The galleries entrance hedge, view looking northeast with Farragut pavilion at right, 2006. Note height of linear section compared with cones. (SUNY ESF).

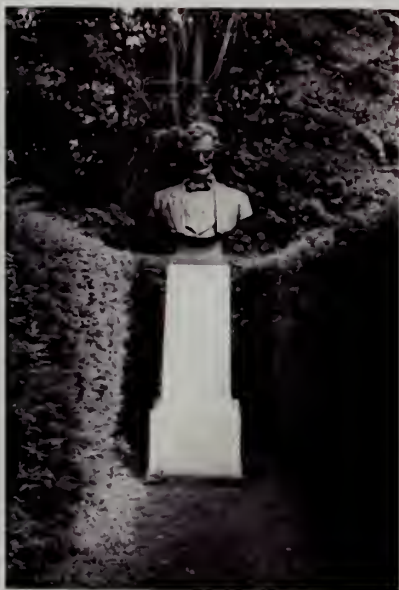
Figure 3.43: The north side of the Lincoln bust hedge, view looking east from Atrium showing encroachment of volunteer vegetation, 2006 (SUNY ESF).

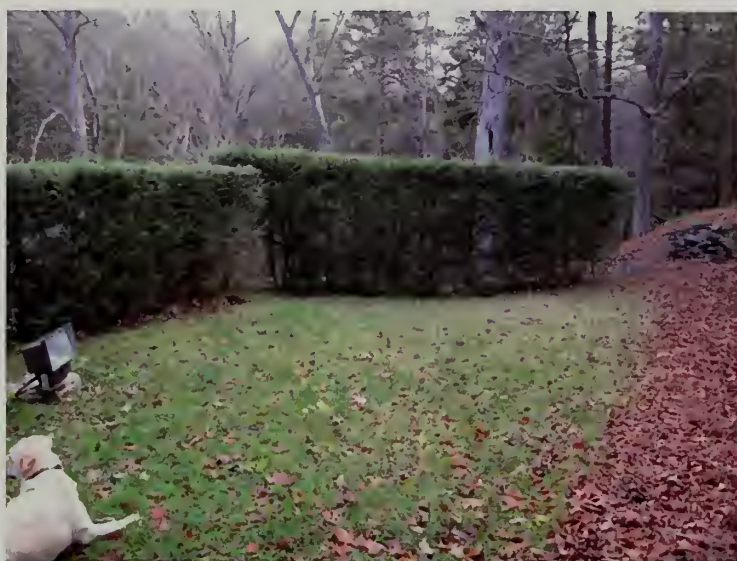
The Lincoln bust hedge is comprised of two adjoining sections of hemlock hedge (H_24, 25) clipped in a rectangular profile (Figure 3.43, Drawing 1). The hedge is situated in a triangular space between the buildings and mature woods that extend across the steep bank that leads to Blow-Me-Down Brook. Section H-24 is 'U'-shaped and frames the narrow 20 foot-long walk leading from the Atrium to the Lincoln bust. Replaced in c.1998, it is 5 feet tall (matching the height of the sculpture pedestal) and 2 feet wide, with a single row and 2 feet spacing between plants. It has a full but thin canopy facing the walk. The north and east (exterior) sides, which are not visible to the public, are mostly bare. These sides of the hedge apparently died off due to shade created by overgrowth of successional trees, vines, and shrubs (grape, honeysuckle, and walnut), which are now cut back from the hedge. Section H-25 frames the east side of the adjoining room to the south, between the Atrium and the Picture Gallery (Figure 3.44). It is 6 feet tall and 4 feet wide, with a single row and 2 foot-spacing between plants. It has a full but thin canopy except on the north side, which is not visible to the public. This side may have died back from competing vegetation, or from shade.

Figure 3.44: The Lincoln bust hedge, view looking east at sections H-25 and 26, 2006. The site of the south leg of H-26 removed in 2006 is the bed at right (SUNY ESF).

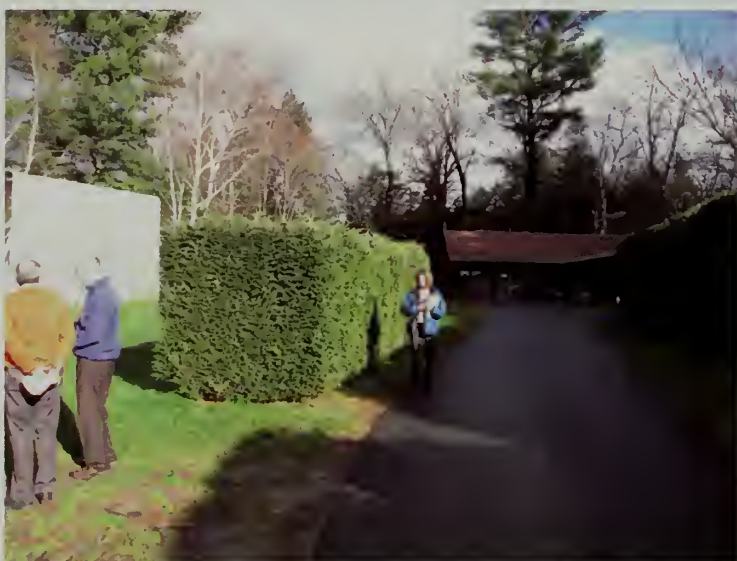
plants (Figure 3.45). It is in excellent condition, with a compact, full canopy. The hedge screens views from the visitor center (former maintenance building) to the north and west.

Figure 3.45: The visitor center hedge, view looking east with visitor center in the right background and Farragut pavilion to the left, 2006 (SUNY ESF).

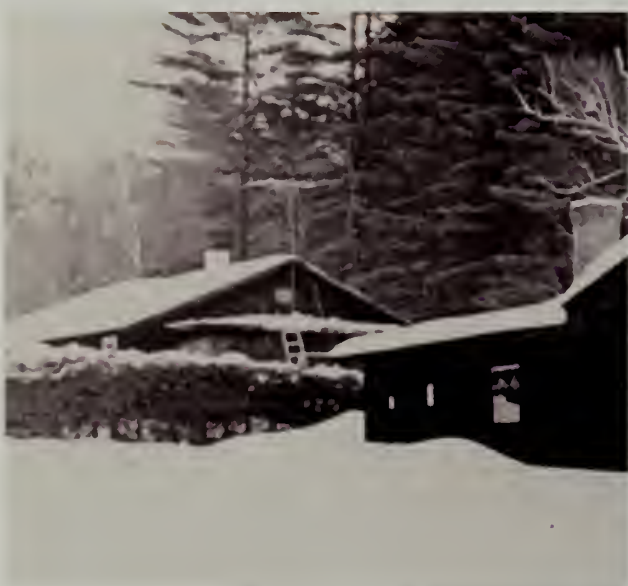
By the mid-1960s, the older section of the hedge extending along the service drive was being maintained at about the height of the eaves of the Caretaker's Cottage (Figure 3.46). In later years, this section grew upwards of 12 feet, concealing all but the upper gable of the cottage when looking from the exterior of the hedge. In c.1980, the section along the road (all or part of H-28) was replanted in hemlock.⁸² This section did not develop strongly most likely due to shade from the woods across the road. In c.2000, a small section of the hedge near the curve along the service drive was replaced due to snow damage.

Figure 3.46: The Caretaker's Cottage hedge, view looking east from the stable showing height after the historic period, c.1970. Note that the hedge was lower than the eaves of the cottage (Saint-Gaudens National Historic Site, photograph 20).

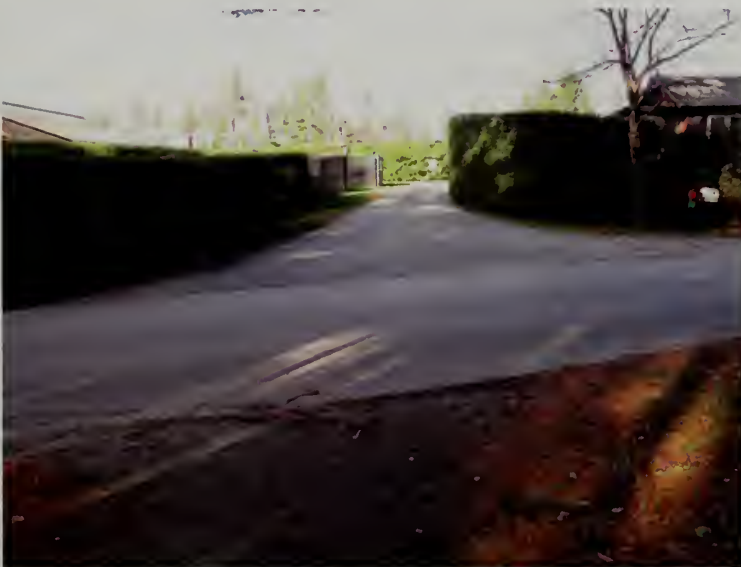
Section H-27, forming the north and west sides of the hedge extending around the curve at the corner of the service drive and Saint Gaudens Road, is mixed white pine and hemlock planted between c.1917 and 1927 with later infill (Figures. 3.47, 3.48). It is 10-12 feet tall and 10 feet wide, planted in a single row with 1 to 3 feet spacing between plants. It is taller than the companion cutting garden hedge on the opposite side of the service drive (see Figure 3.48). The section has three openings: one at the entrance walk to the Caretaker's Cottage, a second to the north of the cottage that is closed by a gate, and a third non-historic narrow arched opening near the east end of the hedge. It has a dense canopy that is mostly full but has some bare spots between the hemlock and white pine. The southeast end of the section, adjoining H-28, was replanted in hemlock in c.2000 as a result of damage from snow.

Figure 3.47: The Caretaker's Cottage hedge, view looking east from the stable, 2006. Note existing height above eaves of the cottage and mixed white pine-hemlock (SUNY ESF).

- Lower Caretaker's Cottage hedge (H-27) to height below eaves of cottage
- Lower Galleries entrance hedge and extend missing part (H-22, 23)
- Lower height of kitchen hedge and address bare understory of dogleg (H-7, 8)

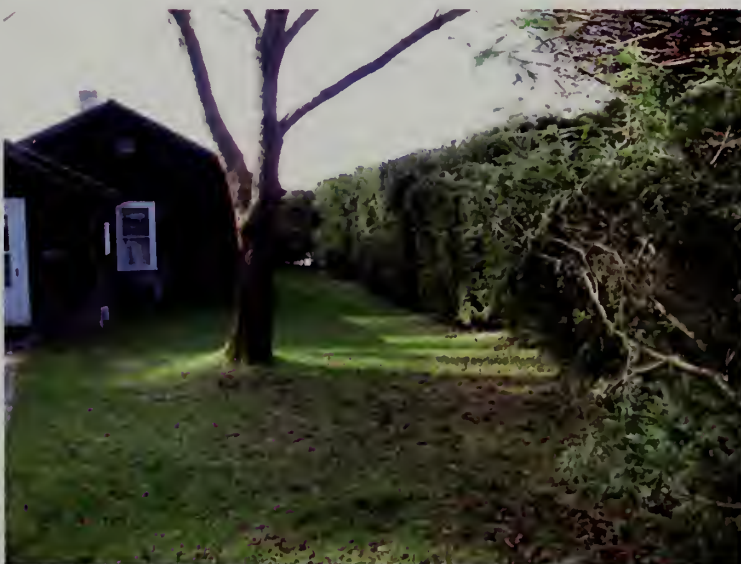
Figure 3.48: The Caretaker's Cottage hedge, view looking north up the service drive, 2006. Note difference in height compared to cutting garden hedge to left of drive (SUNY ESF).

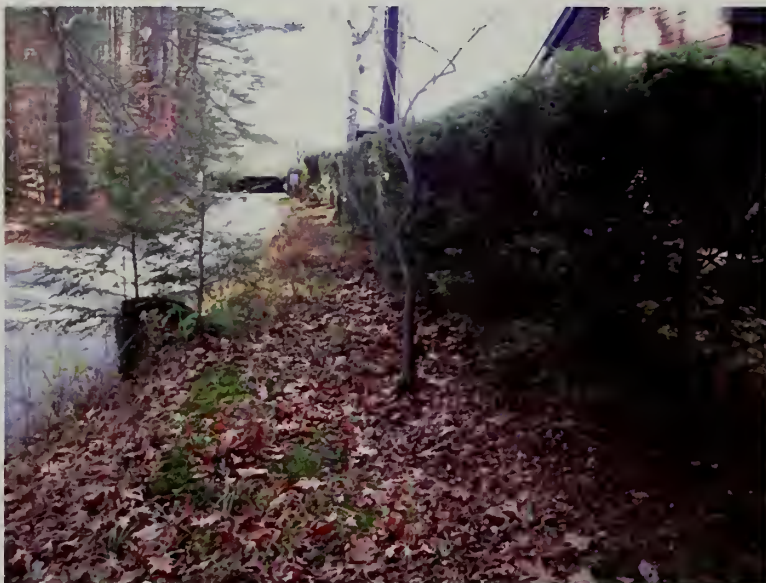
Section H-28, extending along Saint Gaudens Road, is pure hemlock replanted in c.1980 (Figure 3.50). It ranges from 8 feet tall at section H-27 to 5 feet tall to the rear of the garage and visitor center, and averages 4 feet wide. The hedge is full facing the Caretaker's Cottage yard, but is weak on the remainder of the hedge, with gaps and bare areas. The hedge is heavily shaded from the woods south of the road as well as several adjoining trees on the north side, and is situated at the top of a steep bank that is eroding.

Figure 3.49: The Caretaker's Cottage hedge, view looking west of interior of H-27 showing relationship to scale of cottage, 2006 (SUNY ESF).

- Replace roadside hedges when the woods south of Saint Gaudens Road are cleared back to increase light levels (H-2, 3, 5, 28)

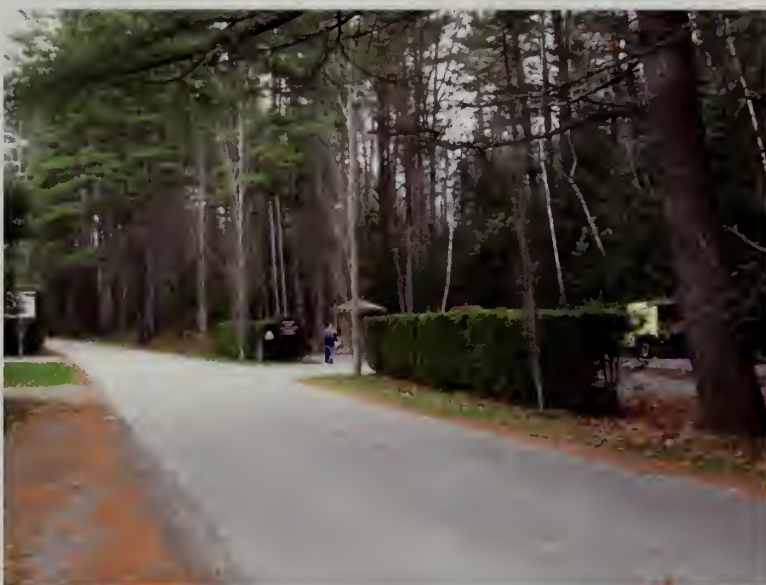
The parking lot hedge, consisting of two symmetrical sections flanking the entrance to the parking lot parallel to Saint Gaudens Road, is pure hemlock planted in c.1988 (Figure 3.51). Each section is 5 to 6 feet tall and 3 feet wide, and is planted in single rows. The hedges are in part shade from the adjoining woods, and each section is flanked on the road side by two Lombardy poplar. Overall the hedges have a full, dense canopy, except for the more heavily shaded interior southwest end of H-30.

Figure 3.50: The Caretaker's Cottage hedge, view looking west from the east end of the hedge along Saint Gaudens Road, 2006 (SUNY ESF).
